ALMEDA SIMS WWTP AND SLUDGE

PROCESSING FACILITY IMPROVEMENTS

Asbestos and Lead Survey Report

Almeda Sims WWTP and Sludge Processing Facility 12319 ½ Almeda Road HOUSTON, TEXAS

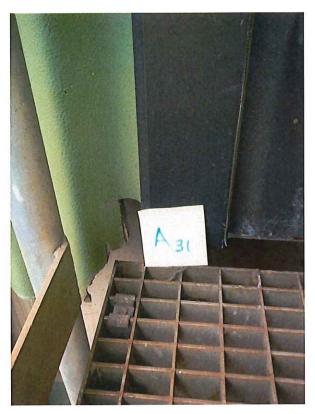
Exterior Siding Belt Press area level 2

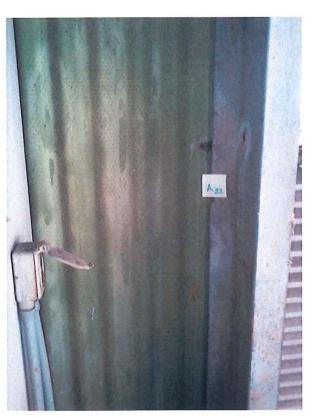
Exterior Siding Belt Press area level 2

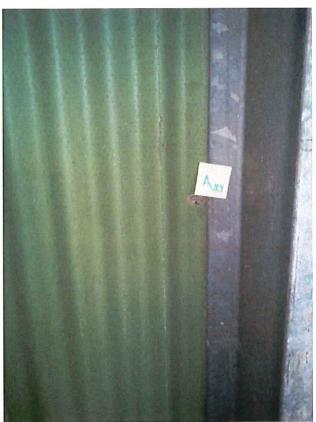
Exterior Siding Belt Press area level 2

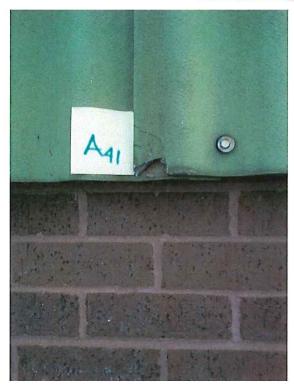
North Exterior Siding

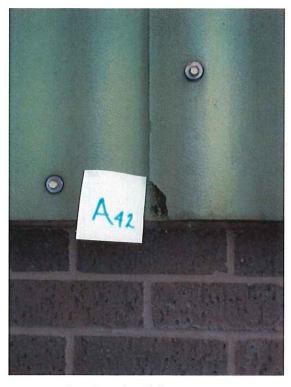
East Exterior Siding

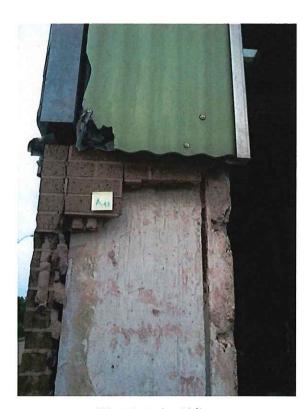
West Exterior Siding

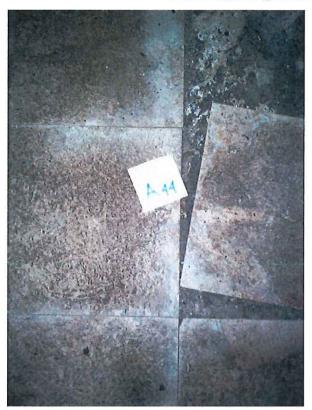
Flooring & Mastic in control room area

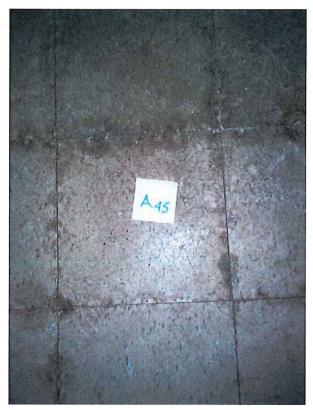
Flooring & Mastic in control room area

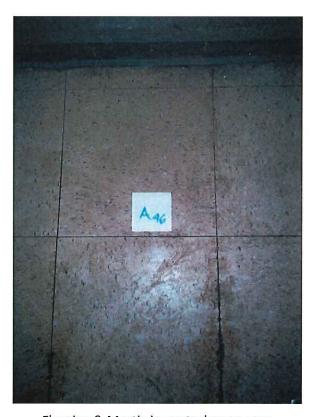
Flooring & Mastic in control room area

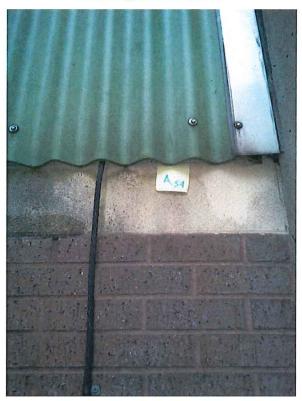
Expansion area between Silo B and Silo C

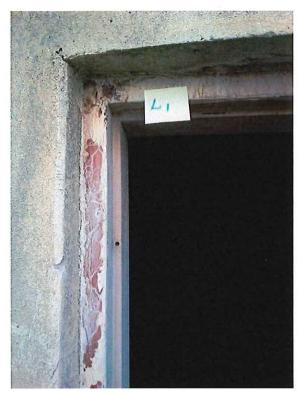
Beige with Red base backing paints on the door frame entrance of Silo A; contains lead levels at 349.4 ppm sample #L1. This is a City of Houston Hazard Category A. Allowable Lead Level, paint material. OSHA regulations apply to workers during demolition or renovation.

Paint Sample - Door Frame entrance Silo A

Recycle all metal components including those with lead containing paint. No lead abatement is required.

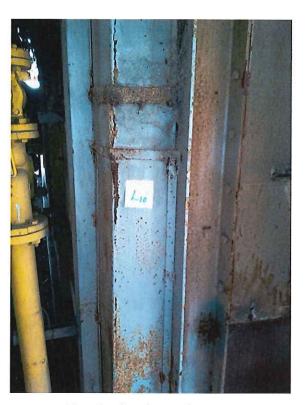
Silver paint on Furnace A&B exterior wall surface contains lead levels at 176.4 ppm sample #L10. This is a City of Houston Hazard Category A. Allowable Lead Levels on paint material. OSHA regulations apply to workers during demolition or renovation.

Exterior Coating on Furnace B

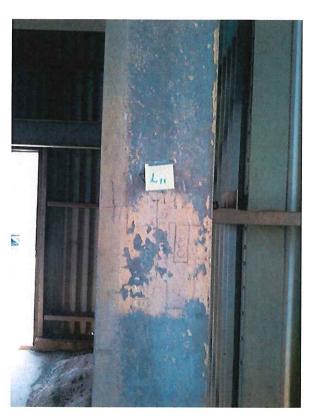
Beige paint on exterior metal support beams of Old loading dock facility contains lead levels at 146 ppm sample #'s L11. This is a City of Houston Hazard Category A. Lead Levels on painted material. OSHA regulations apply to worker during demolition or renovation.

Support Beams Old Loading Building
